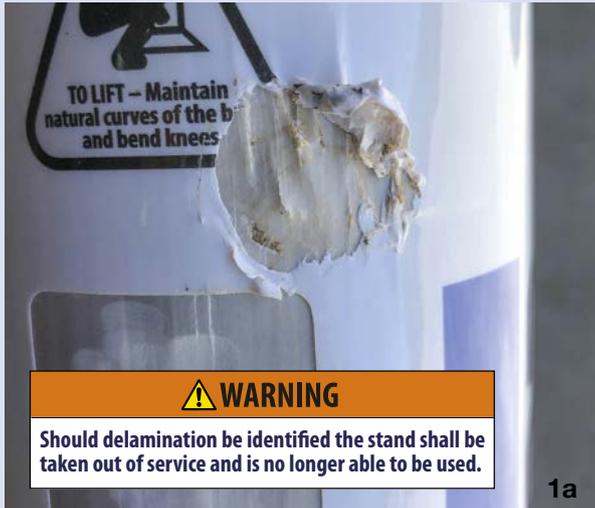
1. IMPACT DAMAGE

Impact damage can cause delamination of the fibre and layers. Delamination occurs when composite is taken beyond its elastic yield point. Upon visual inspection of the upright column in photo 1a it is clear that the stand has been impacted. As you can see, the vinyl label has been damaged and delamination has occurred in the area. While the damaged specimen passed a WLL test, ANY STAND with this type of damage SHALL NOT be used.

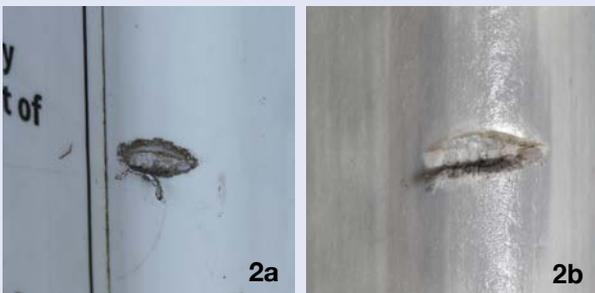
2. CONCENTRATED DAMAGE

Photos 2a and 2b are examples of concentrated damage to a composite column that is greater than 1mm deep. Even though there are no signs of delamination, this level of damage should be referred to your local distributor prior to using the stand.

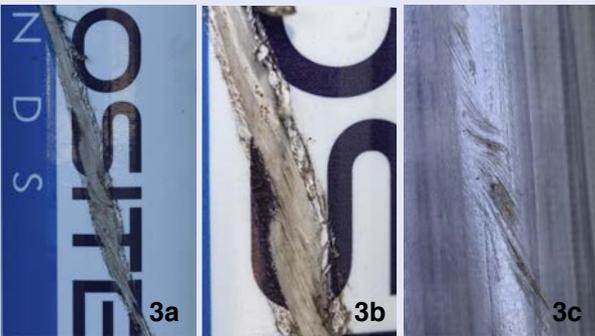
3. ASSESS THE DAMAGE

Should composite damage be identified the vinyl label can be removed to properly assess damage to the Composite Material. In this example, visual damage appears significant (3a & 3b) however, with the label removed (3c), there was only minor damage to the column (less than 0.5mm) with no signs of delamination. This unit passed a WLL test.

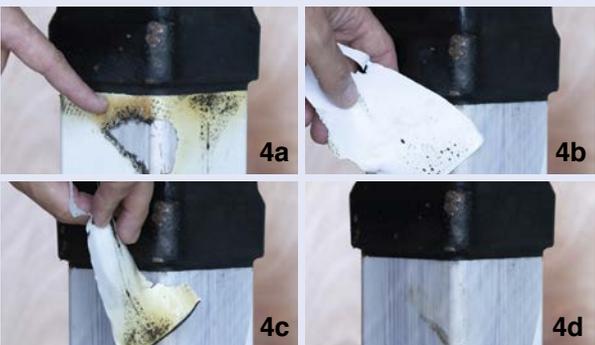
4. HEAT DAMAGE

Composite Stands are not ideally suited to Hot Work and have an operating temperature range of between -20°C and 75°C. Visible signs of heat damage (4a) will appear in the vinyl label long before the Composite Material is compromised.
